Diagnostics of insulators Failures on Overhead Lines

P. Kučík, SlovCert, s.r.o., Bratislava, Slovak Republik
T. Šmida, IBOK, a.s., Bratislava, Slovak Republik**

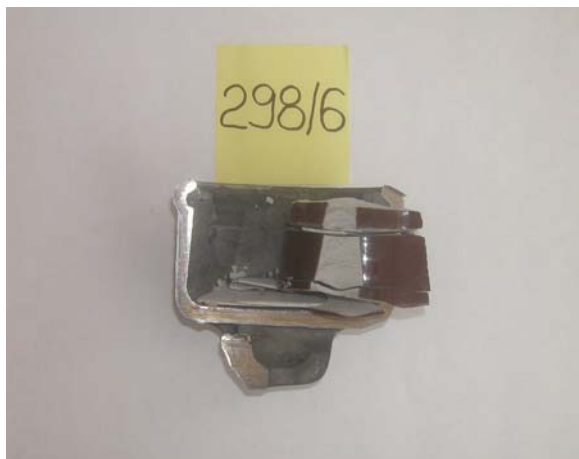
breakdowns it was concluded that a stable crack growth off the perimeter precedes the final fracture taking part at the bulk of the insulator. The main breakdowns were result in destruction of the head of the insulator into slices with flat peripheral region and inded central part (Fig.5 and 6).

Figure 6. Broken insulator with destruction of the head

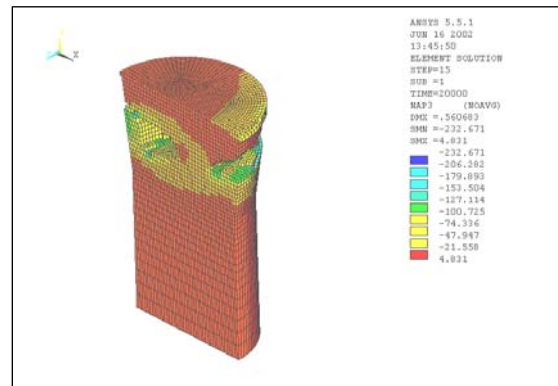
First crack initiate close the upper end of the head insulator mounted in metal armature.

With increasing tensile loading and development of the main crack initiating of the perimeter the stress field in the bulk change form tensile to pressure.

After critical growth of the peripheral crack the bulk of the ceramic fails under pressure. New crack initiates in the remain intact rest of the ceramic insulatorand the whole process repeats several-fold until the lower end of the reinforcement containing the head of the insulator is reached and a final breakdown occur.

Figure 7. The critical growth of the peripheral crack the bulk by FEM numerical analysis.

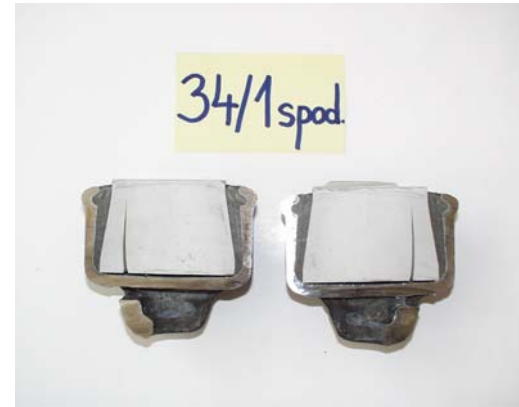
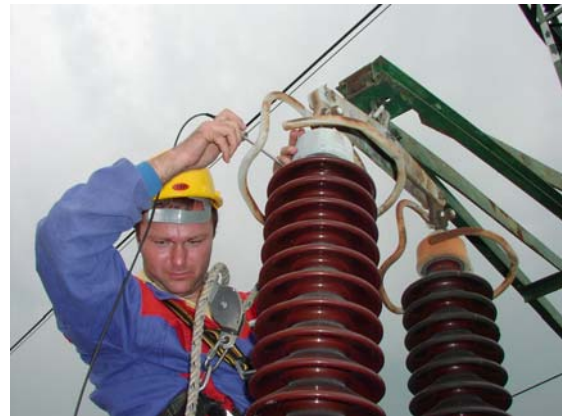
were able to detect critical failures – especially transversal cracks under armature. These cracks particularly can cause to the break of insulator during duty of the high-voltage transmission.

Figure 9. Ultrasonic testing on the hanging ceramic insulators of 440 kV transmission lines

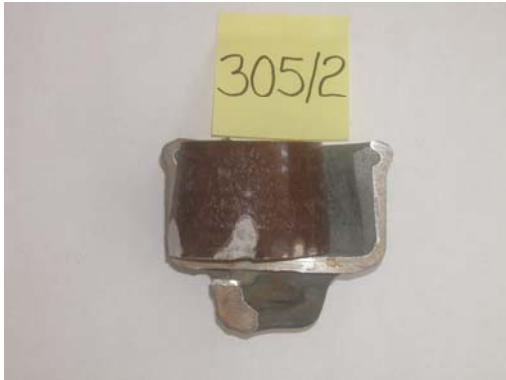
Figure 10. Damages of the edge of insulator

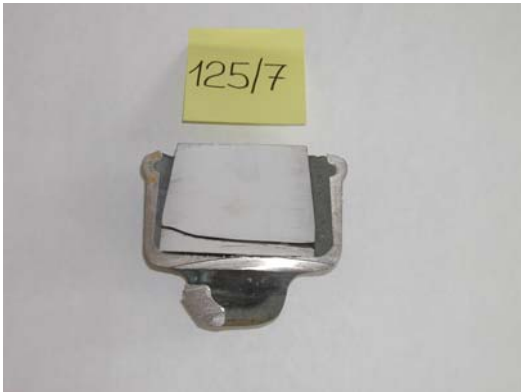
Figure 12. Starting crack growth

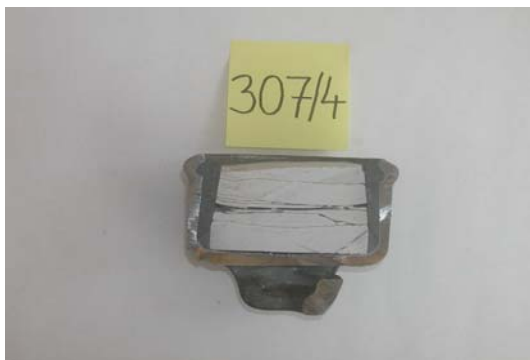
Figure 13. Critical crack growth – the tensile strength of the insulator was less than 80 kN

for tensile strenght. This testing confirm that most critical is cracks growth in the bulk more than 50% of the axial lenght the upper end of the head insulator mounted in metal armature.
